PASSAIC RIVER BASIN
WANAQUE RIVER, PASSAIC COUNTY
NEW JERSEY

LAKE INEZ DAM

NJ 00228

**PHASE 1 INSPECTION REPORT
NATIONAL DAM SAFETY PROGRAM**

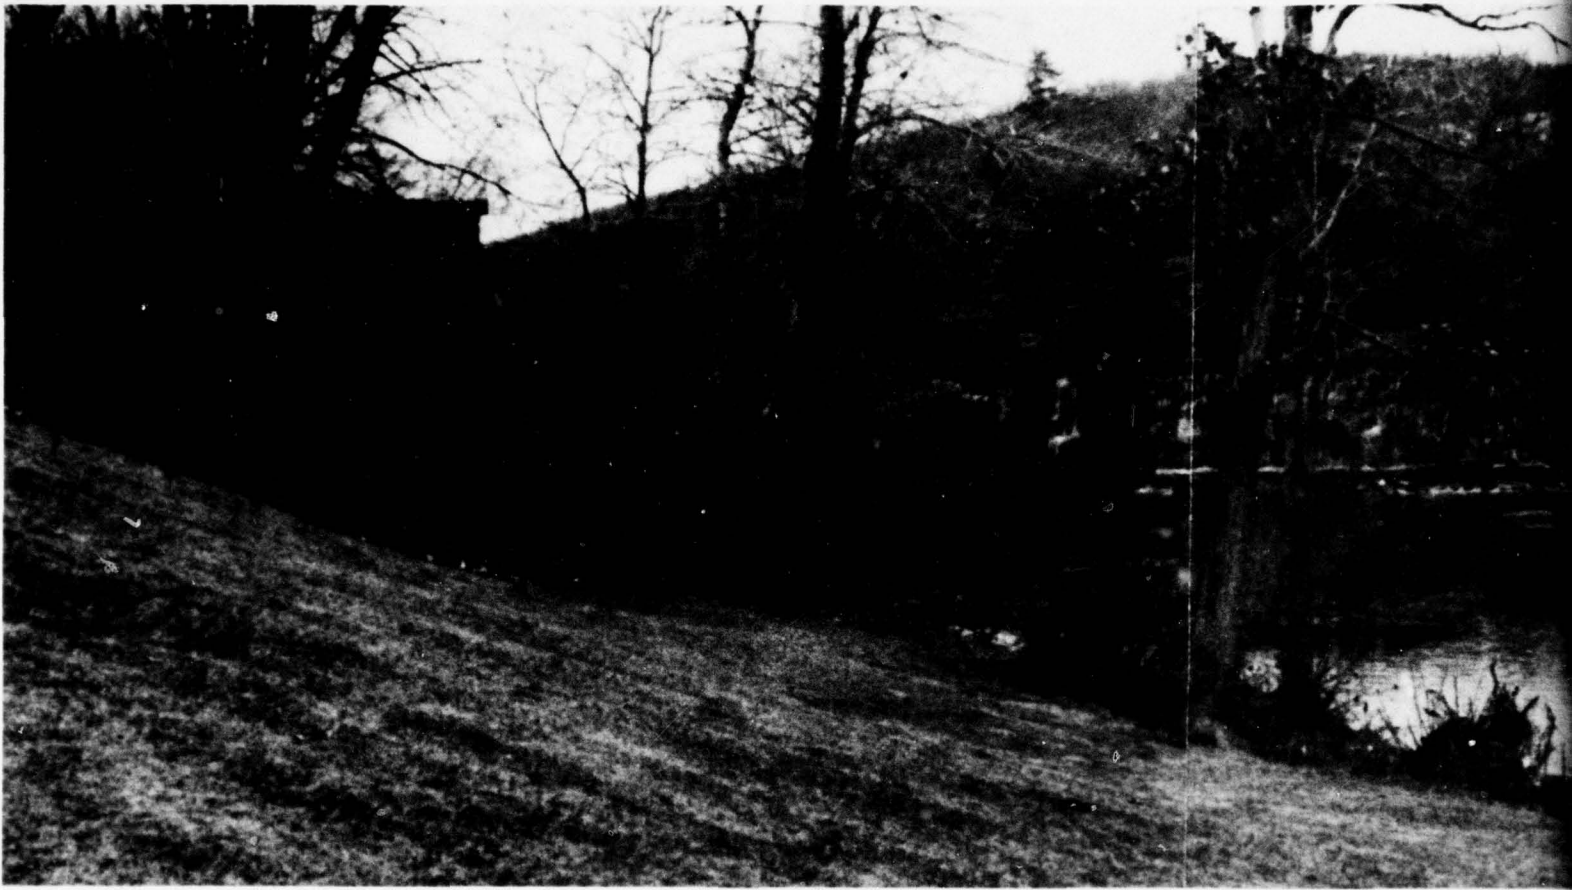
w of dam looking upstream.
(Dec. 3, 1978)

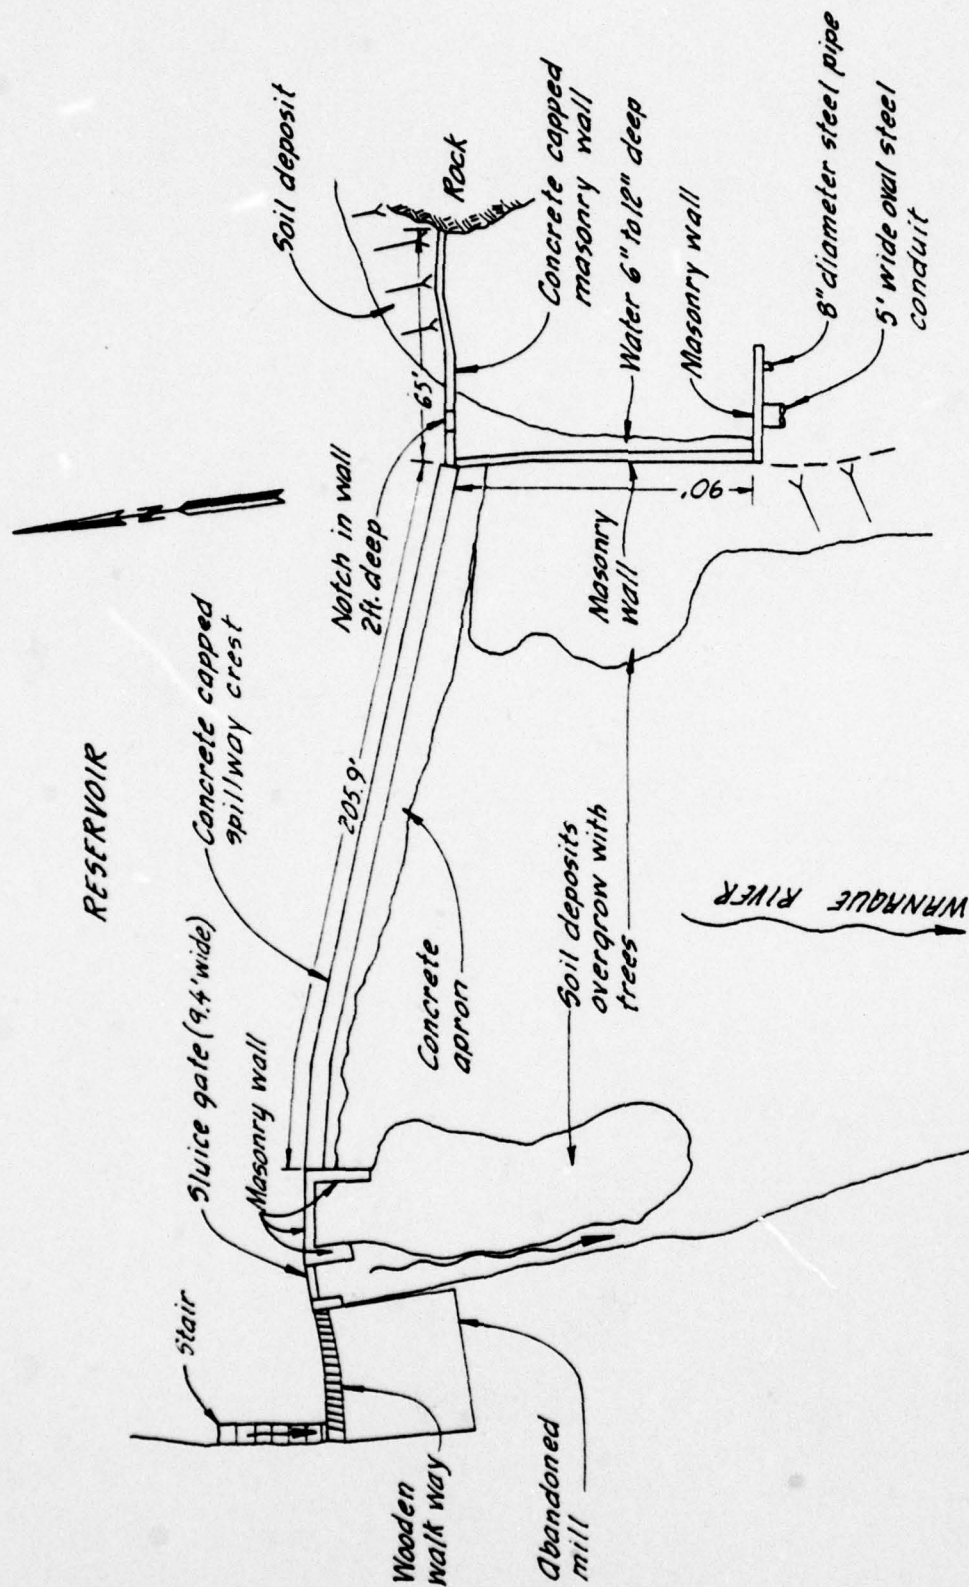
GENERALIZED PLAN BASED ON VISUAL
INSPECTION, DECEMBER 3, 1978

Severe cracking and separation between the concrete cap and masonry were observed at the junction of the left side of the spillway and the dam (Photo 2). Water from the reservoir is leaking through these cracks at an estimated rate of 5 gpm, forming a pond 6 to 12 inches deep. (Plate 2). There is a notch in the left side of the dam approximately 2 feet deep and 6 feet long which may have been associated with the penstock which appears to pass beneath the dam at this location.

An abandoned 5-foot wide steel, oval penstock and an 8-inch diameter steel pipe were observed on the downstream side of the left abutment of the dam (Plate 2 and Photo 8). Water was leaking through both these outlets at a rate of about 10 gpm. There is presently no indication of a power plant or other similar structure in the vicinity

A 9.4-foot wide sluice gate consisting of 4-inch by 8-inch boards is located to the left of the mill at the right side of the dam. The gate controls are inoperable and there is serious leakage between the boards (Photo 9). A small tree growing in the masonry wall adjacent to the sluice is shown in Photo 9. The discharge from the sluice flows adjacent to the old mill and joins the main channel downstream as shown in Plate 2.
